Flood Control Project Maintenance
2014 Structure Summary Report
Overall Unit and Item Ratings

DWR Sutter Maintenance Yard

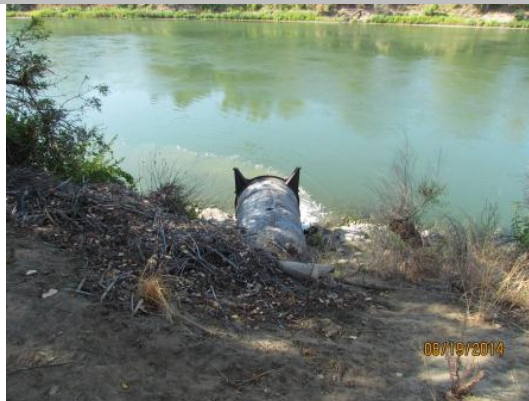
Photo 1 of 4 : ST_2014_NA0060_38_1_20140825_00004.jpg

Butte Slough Drainage structure on the water side.

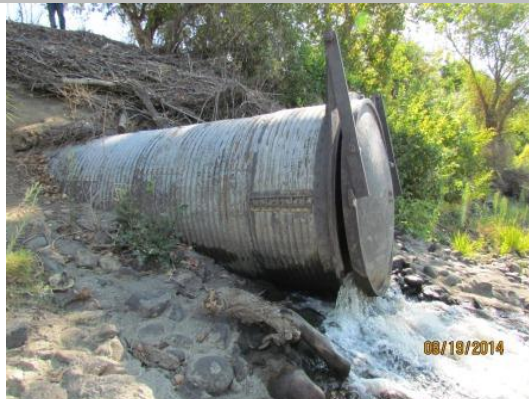
Photo 2 of 4 : ST_2014_NA0060_38_1_20140825_00005.jpg

Butte Slough Drainage structure outfall.

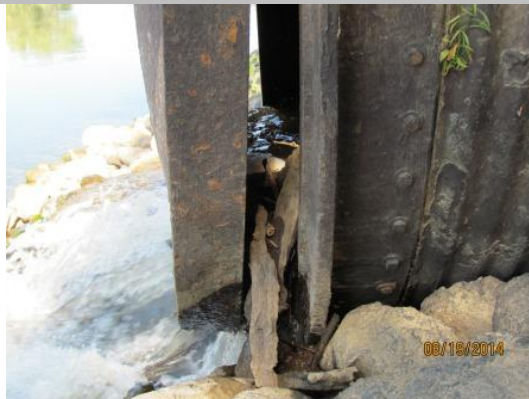
Photo 3 of 4 : ST_2014_NA0060_38_1_20140825_00006.jpg

View of debris preventing the flap gate from proper function.

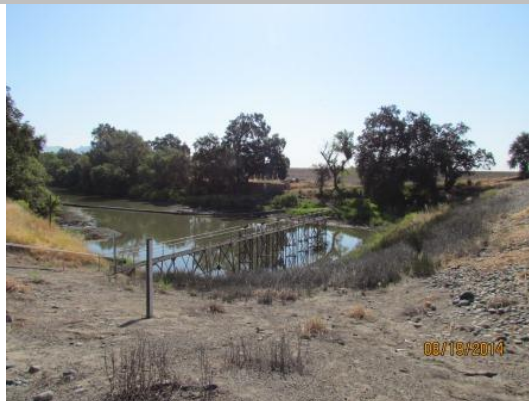
Photo 1 of 4 : ST_2014_NA0060_42_1_20140825_00003.jpg

View of the Butte Slough Outfall Structure on the land side.

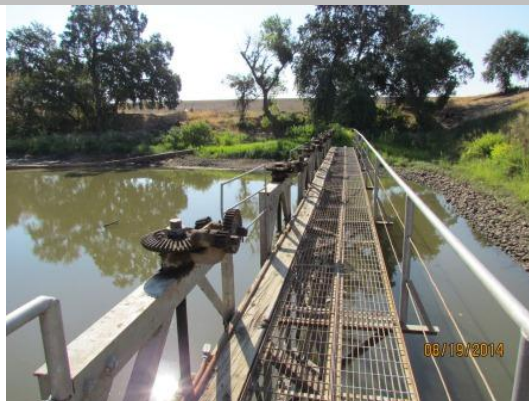
Photo 2 of 4 : ST_2014_NA0060_42_1_20140825_00004.jpg

View of the mechanical gate operation mechanism.

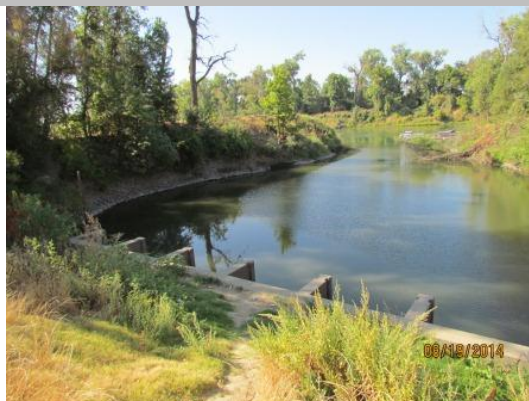
Photo 3 of 4 : ST_2014_NA0060_42_1_20140825_00005.jpg

View of the Butte Slough Outfall Structure on the water side.

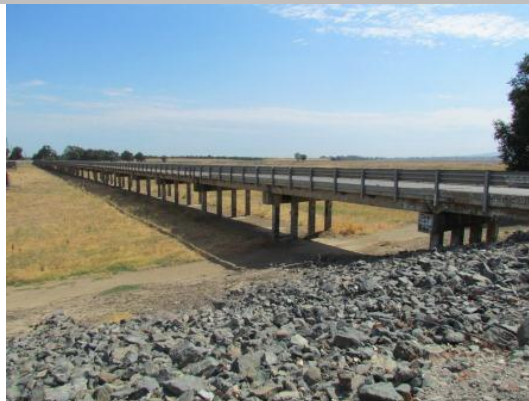
Photo 1 of 4 : ST_2014_NA0060_55_1_20140708_00004.jpg

This view is of the Colusa Weir structure from the right bank of the levee.

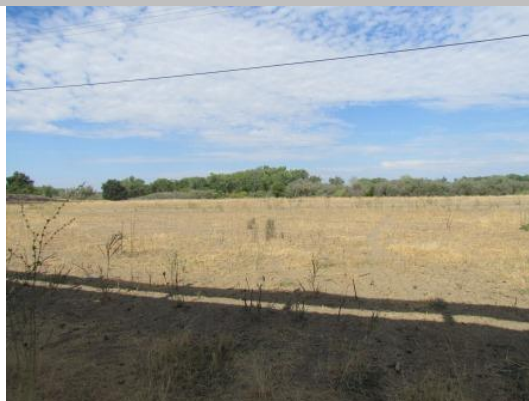
Photo 2 of 4 : ST_2014_NA0060_55_1_20140708_00005.jpg

This is the upstream view of the Colusa Weir structure.

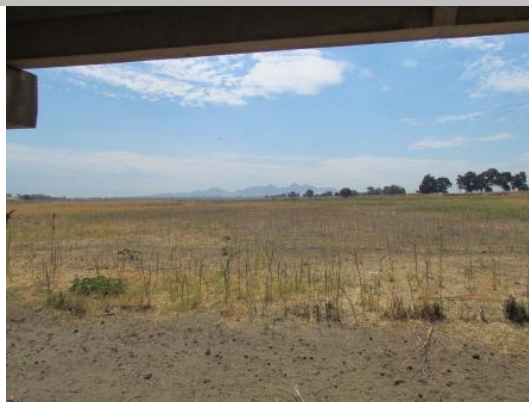
Photo 3 of 4 : ST_2014_NA0060_55_1_20140708_00006.jpg

This is the downstream view of the Colusa Weir structure.

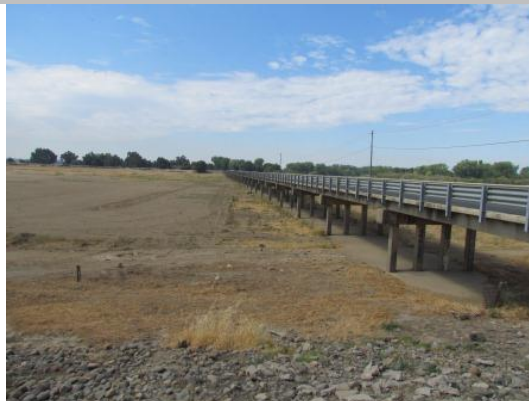
Photo 4 of 4 : ST_2014_NA0060_55_1_20140708_00007.jpg

This view is of the Colusa Weir structure from the left bank of the levee.

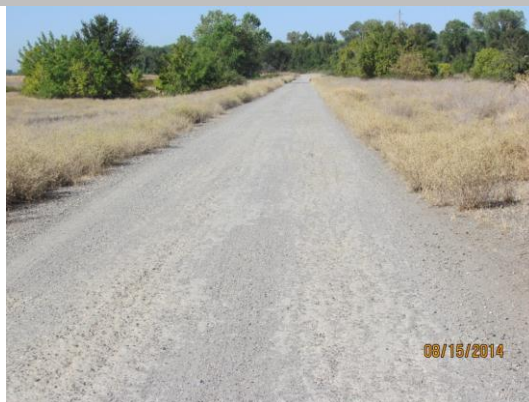
Photo 1 of 1 : ST_2014_NA0060_225_2_20140821_00003.jpg

View of the vegetation on both sides of the weir.

LM Start	0.00	Rating **	M	Issue No.	2
LM End	0.00	Issue Type +	Ma	Location *	LS
Category	Structures & Concrete Lined Channels			GPS Latitude/Longitude	
				Start	End
Item	Vegetation & Obstructions			39.569247 °	39.569247 °
				-121.982569 °	-121.982569 °
DWR ID	DWR_NA0060_225_t_2013_2				
Action/Comments					
Inspector Comments: Spray the vegetation for approximately 100 feet on both sides of the weir.

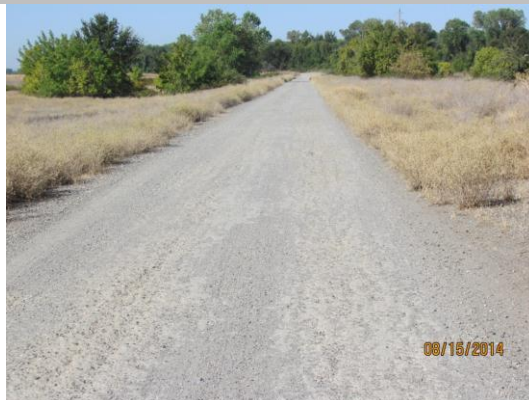
Photo 1 of 1 : ST_2014_NA0060_225_15_20140821_00004.jpg

View of the concrete crown roadway on top of the weir.

LM Start	0.00	Rating **	A	Issue No.	15
LM End	0.00	Issue Type +	Ma	Location *	LS
Category	Structures & Concrete Lined Channels			GPS Latitude/Longitude	
				Start	End
Item	Concrete Surfaces			39.569248 °	39.569248 °
				-121.982569 °	-121.982569 °
DWR ID	DWR_NA0060_225_t_2013_15				
Action/Comments					
Inspector Comments: Farm equipment needs to stay off of the weir to prevent further damage to the concrete surface.

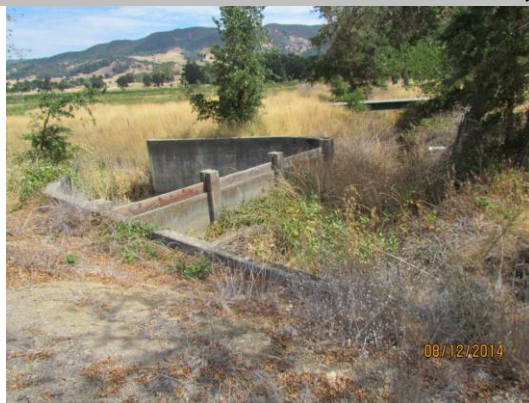
Photo 1 of 2 : ST_2014_NA0060_7_1_20140818_00011.jpg

View of the weir.

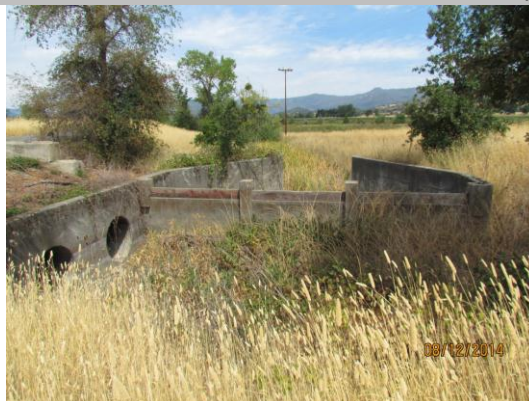
Photo 2 of 2 : ST_2014_NA0060_7_1_20140818_00012.jpg

Alternate view of the weir.

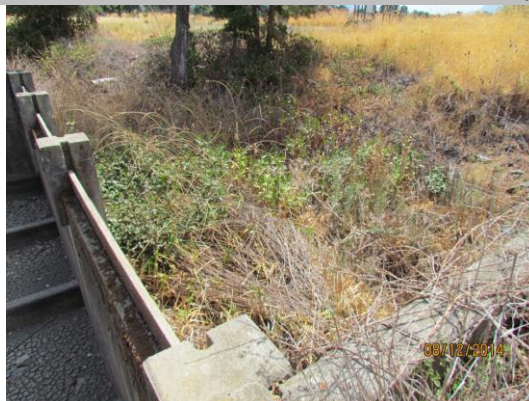
Photo 1 of 3 : ST_2014_NA0060_7_2_20140818_00014.jpg

LM Start	0.00	Rating **	M	Issue No.	2
LM End	0.00	Issue Type +	Ma	Location *	
Category	Structures & Concrete Lined Channels			GPS Latitude/Longitude	
				Start	End
Item	Vegetation & Obstructions			39.126317 °	39.126317 °
				-122.882733 °	-122.882733 °
DWR ID	DWR_NA0009_7_t_2012_2				
Action/Comments					
Inspector Comments: There was vegetation growth such as cat tails

View of the vegetation growth on the inlet of the structure.

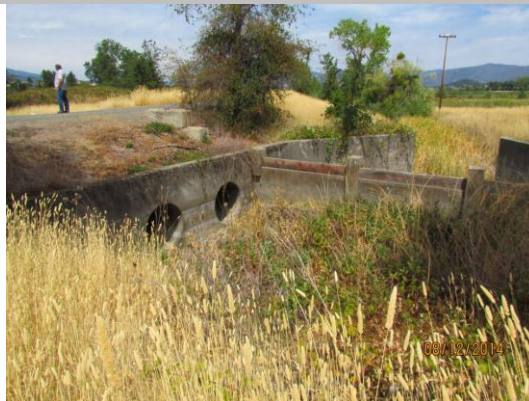
Photo 1 of 2 : ST_2014_NA0060_7_7_20140818_00017.jpg

LM Start	0.00	Rating **	M	Issue No.	7
LM End	0.00	Issue Type +	Ma	Location *	
Category	Structures & Concrete Lined Channels			GPS Latitude/Longitude	
				Start	End
Item	Culverts: Inlets / Outlets			39.126317 °	39.126317 °
				-122.882733 °	-122.882733 °
DWR ID	DWR_NA0009_7_t_2012_7				
Action/Comments					
Inspector Comments: Vegetation was blocking less than 10% of the culverts opening.

View of inlet of the culvert.

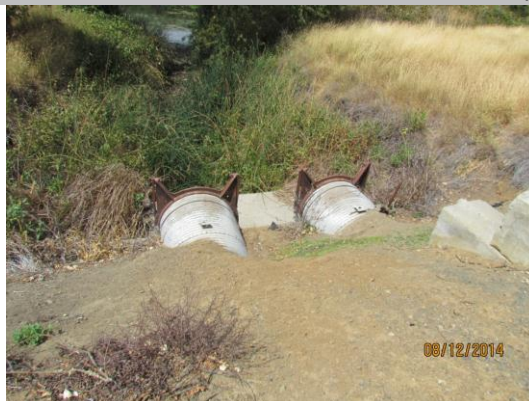
Photo 2 of 2 : ST_2014_NA0060_7_7_20140818_00020.jpg

View of outlet of the structure.

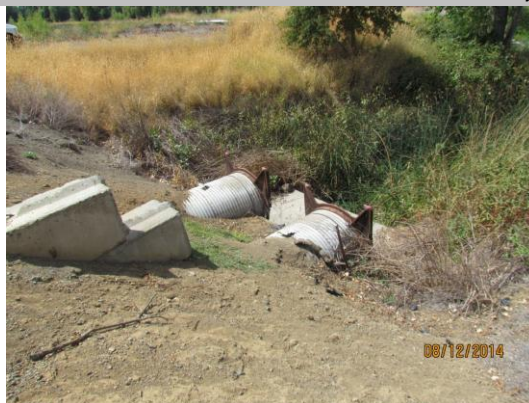
Photo 1 of 1 : ST_2014_NA0060_7_9_20140818_00019.jpg

LM Start	0.00	Rating **	A	Issue No.	9
LM End	0.00	Issue Type +	Ma	Location *	
Category	Structures & Concrete Lined Channels			GPS Latitude/Longitude	
				Start	End
Item	Metal Pipes			39.126317 °	39.126317 °
				-122.882733 °	-122.882733 °
DWR ID	DWR_NA0009_7_t_2012_9				
Action/Comments					
Inspector Comments: The outlet pipes appeared to be in good condition.

View of the outlet pipes.

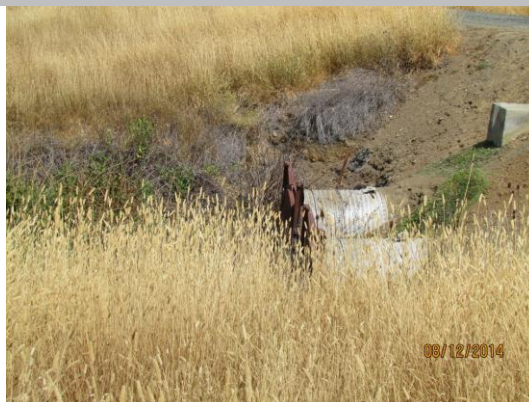
Photo 1 of 2 : ST_2014_NA0060_7_11_20140818_00021.jpg

LM Start	0.00	Rating **	A	Issue No.	11
LM End	0.00	Issue Type +	Ma	Location *	
Category	Structures & Concrete Lined Channels			GPS Latitude/Longitude	
				Start	End
Item	Flap Gates			39.126317 °	39.126317 °
				-122.882733 °	-122.882733 °
DWR ID	DWR_NA0009_7_t_2012_11				
Action/Comments					
Inspector Comments: The flap gates appeared to be in working condition.

View of the flap gates.

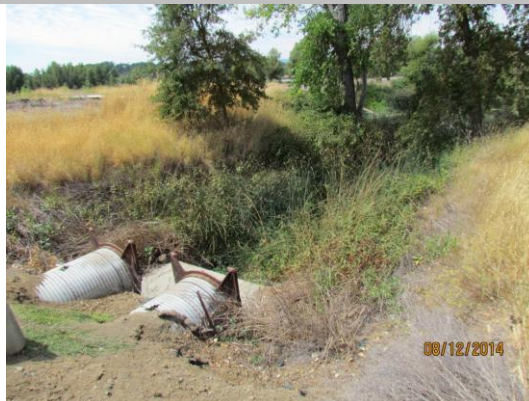
Photo 2 of 2 : ST_2014_NA0060_7_11_20140818_00023.jpg

LM Start	0.00	Rating **	A	Issue No.	11 (cont)
LM End	0.00	Issue Type +	Ma	Location *	
Category	Structures & Concrete Lined Channels			GPS Latitude/Longitude	
				Start	End
Item	Flap Gates			39.126317 °	39.126317 °
				-122.882733 °	-122.882733 °
DWR ID	DWR_NA0009_7_t_2012_11				
Action/Comments					
Inspector Comments: The flap gates appeared to be in working condition.

An alternate view of the flap gates.

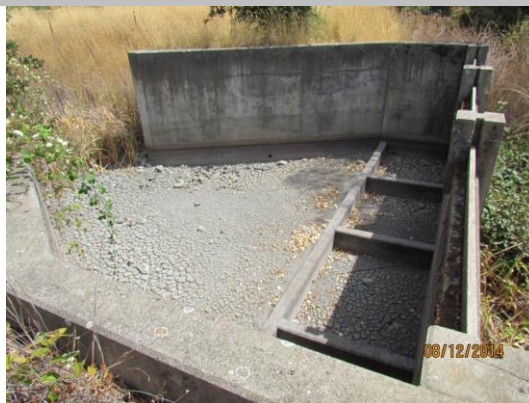
Photo 1 of 1 : ST_2014_NA0060_7_15_20140818_00022.jpg

LM Start	0.00	Rating **	A	Issue No.	15
LM End	0.00	Issue Type +	Ma	Location *	
Category	Structures & Concrete Lined Channels			GPS Latitude/Longitude	
				Start	End
Item	Concrete Surfaces			39.126317 °	39.126317 °
				-122.882733 °	-122.882733 °
DWR ID	DWR_NA0009_7_t_2012_15				
Action/Comments					
Inspector Comments: There was minimal cracking and scaling on the concrete structure, but it didn't threaten structural integrity.

View of the concrete structure.

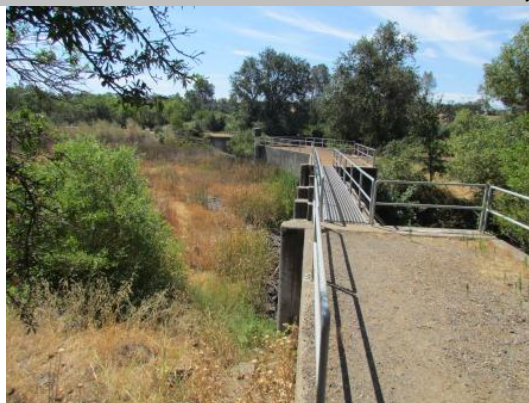
Photo 1 of 4 : ST_2014_NA0060_9_1_20140721_00008.jpg

This is a photo of the control structure.

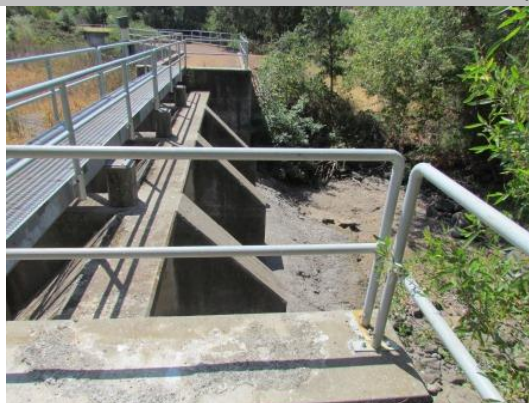
Photo 2 of 4 : ST_2014_NA0060_9_1_20140721_00009.jpg

This is a photo of the downstream side of the control structure.

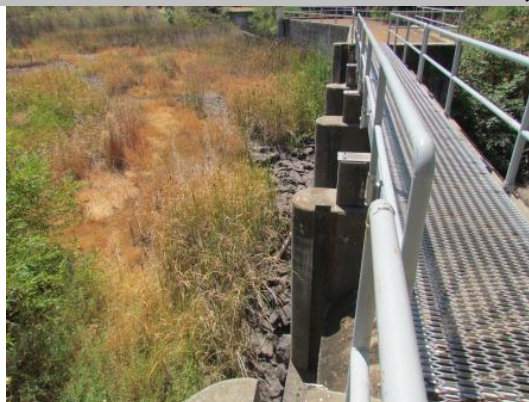
Photo 3 of 4 : ST_2014_NA0060_9_1_20140721_00010.jpg

This is a photo of the upstream side of the control structure.

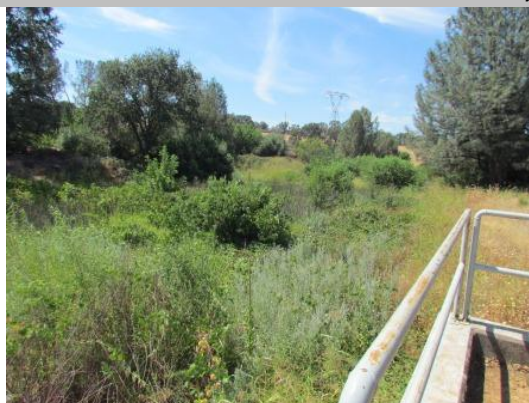
Photo 1 of 2 : ST_2014_NA0060_9_2_20140721_00006.jpg

LM Start	0.00	Rating **	M	Issue No.	2
LM End	0.00	Issue Type +	Ma	Location *	
Category	Structures & Concrete Lined Channels			GPS Latitude/Longitude	
				Start	End
Item	Vegetation & Obstructions			39.733767 °	39.733767 °
				-121.771915 °	-121.771915 °
DWR ID	DWR_NA0060_9_t_2012_2				
Action/Comments					
Inspector Comments: There is some vegetation, a few small trees, and some debris on the weir. The flow may be impeded.

This is a view looking downstream.

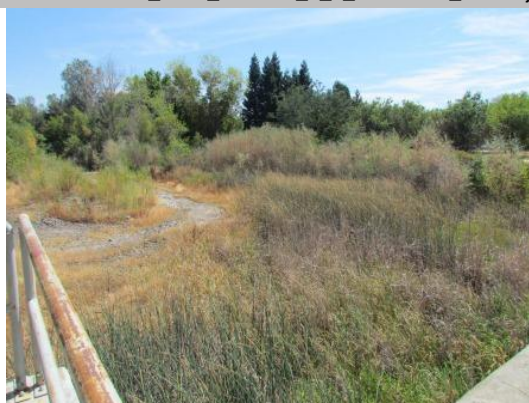
Photo 2 of 2 : ST_2014_NA0060_9_2_20140721_00007.jpg

This is a view looking upstream.

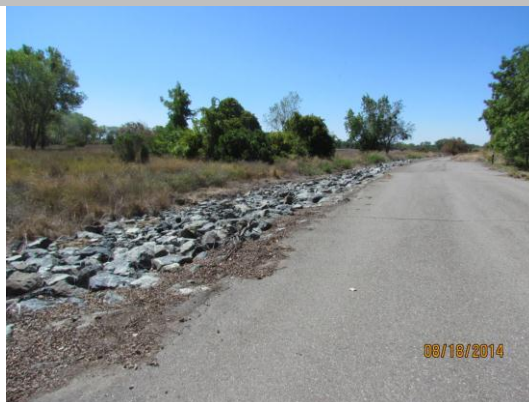
Photo 1 of 1 : ST_2014_NA0060_228_2_20140821_00003.jpg

View of the vegetation that is next to the weir.

LM Start	0.00	Rating **	M	Issue No.	2
LM End	0.00	Issue Type +	Ma	Location *	WS
Category	Structures & Concrete Lined Channels			GPS Latitude/Longitude	
				Start	End
Item	Vegetation & Obstructions			39.674690 °	39.674690 °
				-121.947013 °	-121.947013 °
DWR ID	DWR_NA0014_228_t_2013_2				
Action/Comments					
Inspector Comments: The vegetation should be sprayed back approximately 20 feet from both sides of the weir.

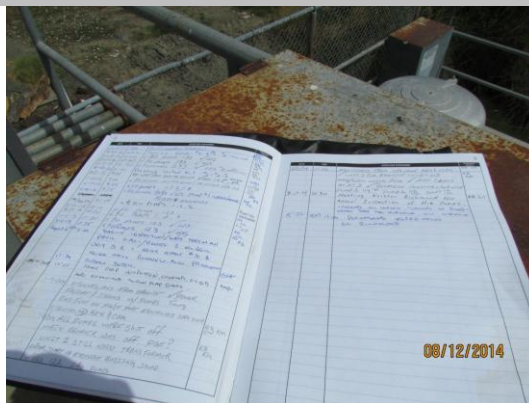
Photo 1 of 1 : ST_2014_NA0060_17_1_20140819_00017.jpg

LM Start	0.00	Rating **	A	Issue No.	1
LM End	0.00	Issue Type +	Ma	Location *	
Category	Pump Stations			GPS Latitude/Longitude	
				Start	End
Item	Operating Log			39.142300 °	39.142300 °
				-122.902350 °	-122.902350 °
DWR ID	DWR_NA0060_17_t_2012_1				
Action/Comments					
Inspector Comments: The operation log was up to date and present at the pump station.

View of the operation log.

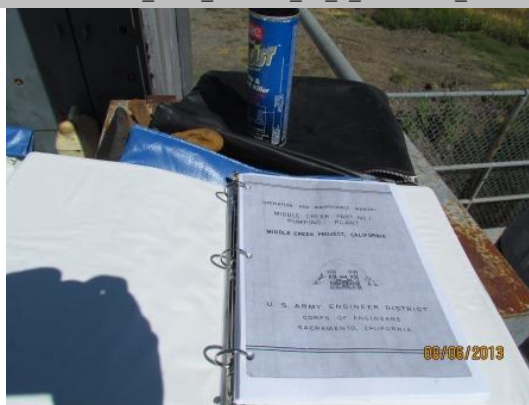
Photo 1 of 1 : ST_2014_NA0060_17_2_20140709_00002.jpg

LM Start	0.00	Rating **	A	Issue No.	2
LM End	0.00	Issue Type +	Ma	Location *	
Category	Pump Stations			GPS Latitude/Longitude	
				Start	End
Item	Operation & Maintenance Manual			39.142300 °	39.142300 °
				-122.902350 °	-122.902350 °
DWR ID	DWR_NA0060_17_t_2012_2				
Action/Comments					
Inspector Comments: The O&M manual was present at the pumping plant.

View of the O&M manual.

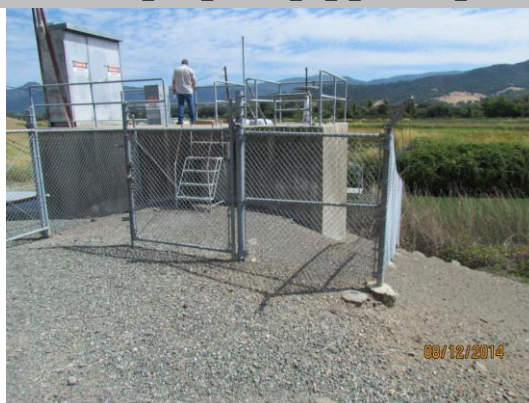
Photo 1 of 1 : ST_2014_NA0060_17_5_20140819_00020.jpg

LM Start	0.00	Rating **	A	Issue No.	5
LM End	0.00	Issue Type +	Ma	Location *	
Category	Pump Stations			GPS Latitude/Longitude	
				Start	End
Item	Safety			39.142300 °	39.142300 °
				-122.902350 °	-122.902350 °
DWR ID	DWR_NA0060_17_t_2012_5				
Action/Comments					
Inspector Comments: No safety hazard was present around the plant. All of the rail guards and fences were secured and in good condition.

View of the security fence and guard rails around the pumping plant.

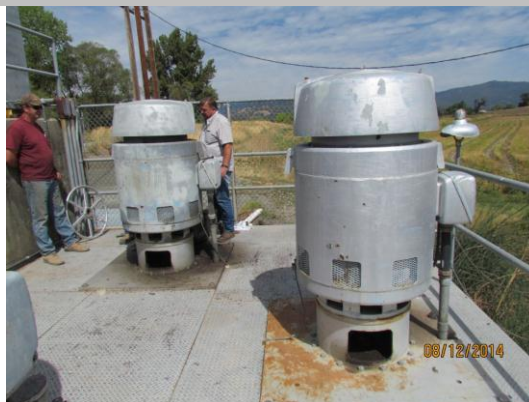
Photo 1 of 3 : ST_2014_NA0060_17_7_20140819_00021.jpg

LM Start	0.00	Rating **	A	Issue No.	7
LM End	0.00	Issue Type +	Ma	Location *	
Category	Pump Stations			GPS Latitude/Longitude	
				Start	End
Item	Pumps			39.142300 °	39.142300 °
				-122.902350 °	-122.902350 °
DWR ID	DWR_NA0060_17_t_2012_7				
Action/Comments					
Inspector Comments: The pumps appeared to be in good working condition and properly maintained including proper lubrication level.

View of the pumps.

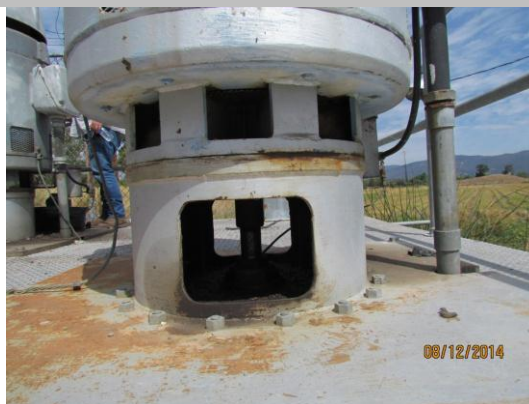
Photo 2 of 3 : ST_2014_NA0060_17_7_20140819_00022.jpg

View of bottom of a pump.

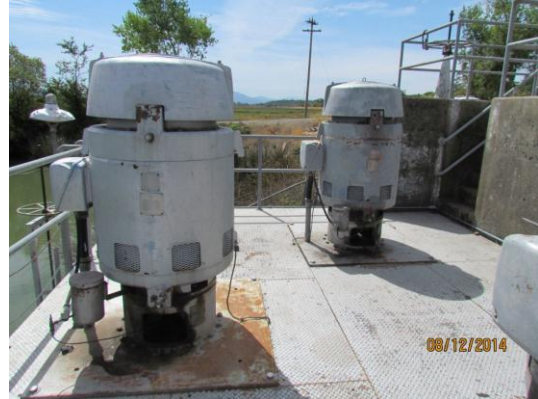
Photo 3 of 3 : ST_2014_NA0060_17_7_20140819_00023.jpg

LM Start	0.00	Rating **	A	Issue No.	7 (cont)	
LM End	0.00	Issue Type +	Ma	Location *		
Category	Pump Stations			GPS Latitude/Longitude		
				Start	End	
Item	Pumps			39.142300 °	39.142300 °	
				-122.902350 °	-122.902350 °	
DWR ID	DWR_NA0060_17_t_2012_7					
Action/Comments						
Inspector Comments: The pumps appeared to be in good working

View of the two of the three pumps.

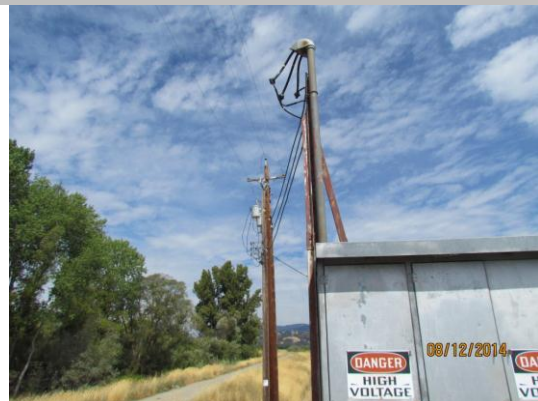
Photo 1 of 1 : ST_2014_NA0060_17_8_20140819_00024.jpg

LM Start	0.00	Rating **	A	Issue No.	8
LM End	0.00	Issue Type +	Ma	Location *	
Category	Pump Stations			GPS Latitude/Longitude	
				Start	End
Item	Power			39.142300 °	39.142300 °
				-122.902350 °	-122.902350 °
DWR ID	DWR_NA0060_17_t_2012_8				
Action/Comments					
Inspector Comments: The power source appeared to be reliable and safe.

View of the power source of the plant.

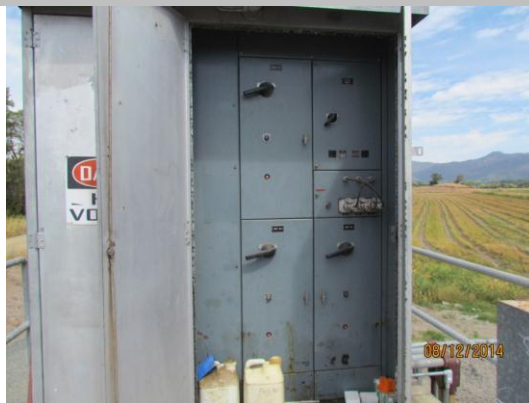
Photo 1 of 1 : ST_2014_NA0060_17_11_20140819_00025.jpg

LM Start	0.00	Rating **	A	Issue No.	11
LM End	0.00	Issue Type +	Ma	Location *	
Category	Pump Stations			GPS Latitude/Longitude	
				Start	End
Item	Pump Control Systems			39.142300 °	39.142300 °
				-122.902350 °	-122.902350 °
DWR ID	DWR_NA0060_17_t_2012_11				
Action/Comments					
Inspector Comments: The pump control systems appeared to be operational and free of damage.

View of the pump control systems.

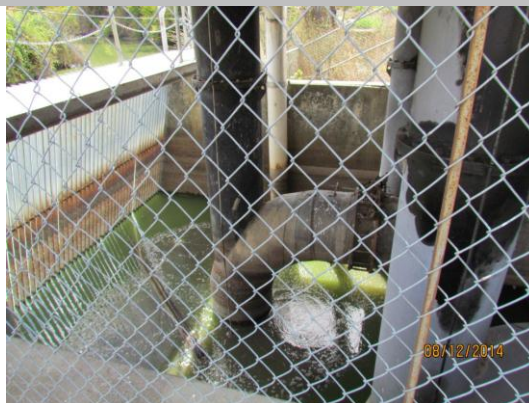
Photo 1 of 1 : ST_2014_NA0060_17_12_20140819_00032.jpg

LM Start	0.00	Rating **	A	Issue No.	12
LM End	0.00	Issue Type +	Ma	Location *	
Category	Pump Stations			GPS Latitude/Longitude	
				Start	End
Item	Sumps/Wet Well			39.142300 °	39.142300 °
				-122.902350 °	-122.902350 °
DWR ID	DWR_NA0060_17_t_2013_12				
Action/Comments					
Inspector Comments: Wet wells were clear of debris.

View of the wet well.

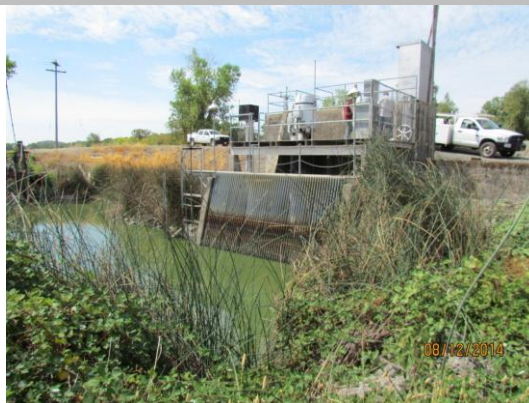
Photo 1 of 1 : ST_2014_NA0060_17_13_20140819_00027.jpg

LM Start	0.00	Rating **	A	Issue No.	13
LM End	0.00	Issue Type +	Ma	Location *	
Category	Pump Stations			GPS Latitude/Longitude	
				Start	End
Item	Trash Racks			39.142300 °	39.142300 °
				-122.902350 °	-122.902350 °
DWR ID	DWR_NA0060_17_t_2012_13				
Action/Comments					
Inspector Comments: Trash racks appeared to be in good condition and free of debris.

View of the trash racks.

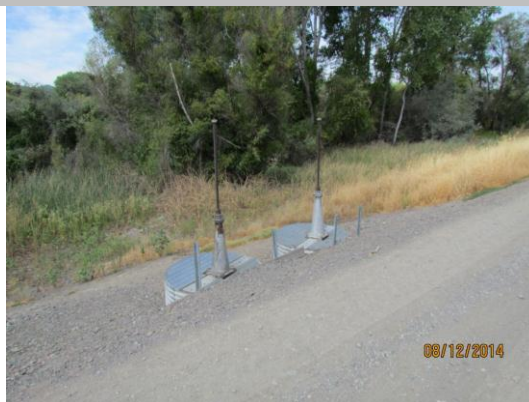
Photo 1 of 2 : ST_2014_NA0060_17_15_20140819_00028.jpg

LM Start	0.00	Rating **	A	Issue No.	15
LM End	0.00	Issue Type +	Ma	Location *	
Category	Pump Stations			GPS Latitude/Longitude	
				Start	End
Item	Sluice / Slide Gates			39.142300 °	39.142300 °
				-122.902350 °	-122.902350 °
DWR ID	DWR_NA0060_17_t_2013_15				
Action/Comments					
Inspector Comments: The slide gates appeared to be in a good working condition.

View of the slide gates.

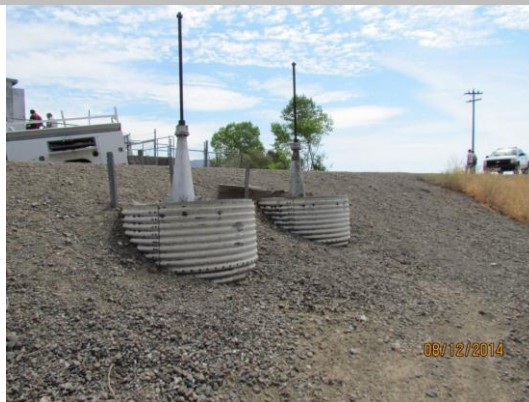
Photo 2 of 2 : ST_2014_NA0060_17_15_20140819_00029.jpg

An alternate view of the slide gates.

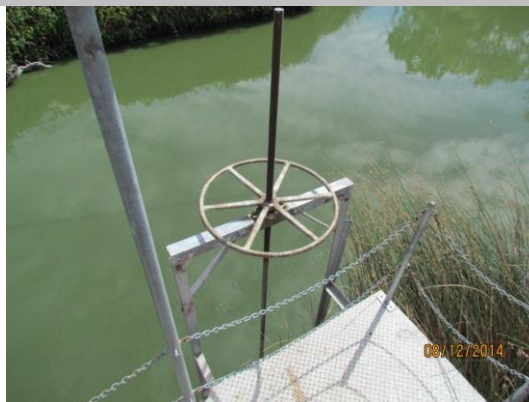
Photo 1 of 2 : ST_2014_NA0060_17_17_20140819_00030.jpg

LM Start	0.00	Rating **	A	Issue No.	17
LM End	0.00	Issue Type +	Ma	Location *	
Category	Pump Stations			GPS Latitude/Longitude	
				Start	End
Item	Manual Gate Operators			39.142300 °	39.142300 °
				-122.902350 °	-122.902350 °
DWR ID	DWR_NA0060_17_t_2012_17				
Action/Comments					
Inspector Comments: The manual gate operators appeared to be in good working condition.

View of one of the manual operators at the plant.

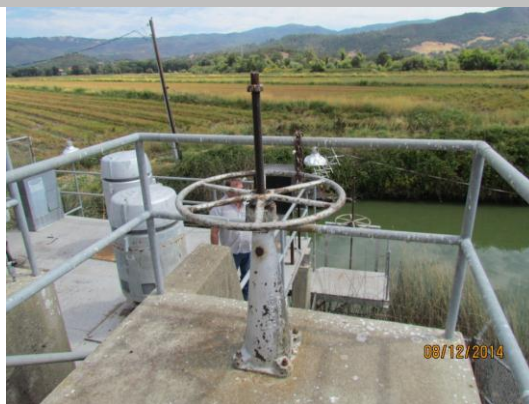
Photo 2 of 2 : ST_2014_NA0060_17_17_20140819_00031.jpg

View of a manual operator at the plant.

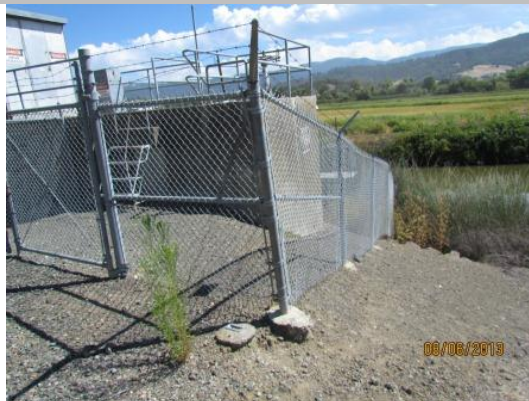
Photo 1 of 1 : ST_2014_NA0060_17_21_20140709_00016.jpg

LM Start	0.00	Rating **	A	Issue No.	21
LM End	0.00	Issue Type +	Ma	Location *	
Category	Pump Stations			GPS Latitude/Longitude	
				Start	End
Item	Security Fencing			39.142300 °	39.142300 °
				-122.902350 °	-122.902350 °
DWR ID	DWR_NA0060_17_t_2012_21				
Action/Comments					
Inspector Comments: Security fencing appeared to be in good condition.

View of the security fencing around the plant.

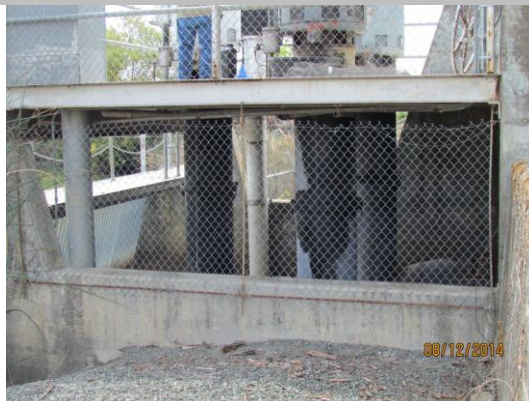
Photo 1 of 1 : ST_2014_NA0060_17_22_20140819_00033.jpg

LM Start	0.00	Rating **	A	Issue No.	22
LM End	0.00	Issue Type +	Ma	Location *	
Category	Pump Stations			GPS Latitude/Longitude	
				Start	End
Item	Intake and Discharge Pipes			39.142300 °	39.142300 °
				-122.902350 °	-122.902350 °
DWR ID	DWR_NA0060_17_t_2012_22				
Action/Comments					
Inspector Comments: The pipes appeared to be in good working condition.

View of the intake pipes at the pumping plant.

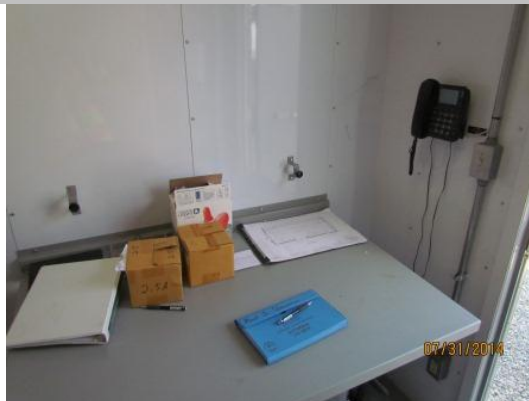
Photo 1 of 1 : ST_2014_NA0060_21_1_20140731_00011.jpg

LM Start	0.00	Rating **	A	Issue No.	1	
LM End	0.00	Issue Type +	Ma	Location *		
Category	Pump Stations			GPS Latitude/Longitude		
				Start	End	
Item	Operating Log			38.931815 °	38.931815 °	
				-121.634331 °	-121.634331 °	
DWR ID	DWR_NA0060_21_t_2012_1					
Action/Comments						
Inspector Comments: The operating log is kept on site.

View of the operating log and telephone.

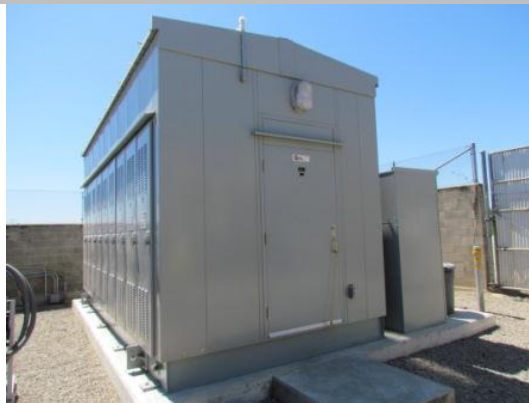
Photo 1 of 1 : ST_2014_NA0060_21_3_20140630_00001.jpg

LM Start	0.00	Rating **	A	Issue No.	3
LM End	0.00	Issue Type +	Ma	Location *	
Category	Pump Stations			GPS Latitude/Longitude	
				Start	End
Item	Plant Building			38.931815 °	38.931815 °
				-121.634331 °	-121.634331 °
DWR ID	DWR_NA0060_21_t_2012_3				
Action/Comments					
Inspector Comments: Plant building is mostly complete and appears to be in good working order. The project is currently under construction.

View of plant building under construction.

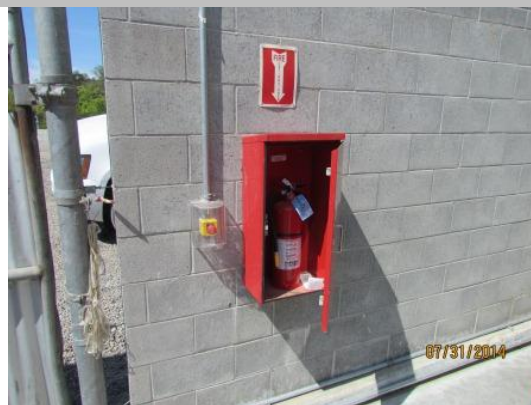
Photo 1 of 1 : ST_2014_NA0060_21_5_20140731_00012.jpg

LM Start	0.00	Rating **	A	Issue No.	5
LM End	0.00	Issue Type +	Ma	Location *	
Category	Pump Stations			GPS Latitude/Longitude	
				Start	End
Item	Safety			38.931815 °	38.931815 °
				-121.634331 °	-121.634331 °
DWR ID	DWR_NA0060_21_t_2012_5				
Action/Comments					
Inspector Comments: Site is under construction safety wear is required during construction (hard hat, vest and eyewear).

View of the fire extinguisher and emergency shutoff switch.

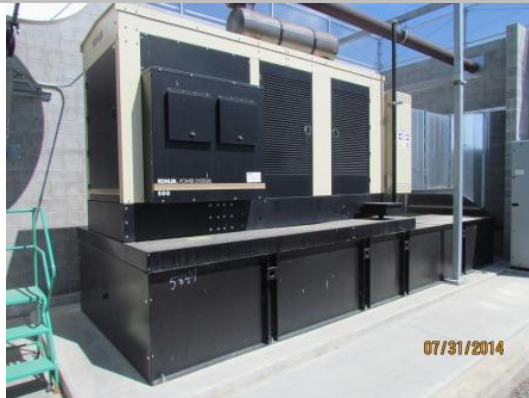
Photo 1 of 1 : ST_2014_NA0060_21_8_20140731_00013.jpg

LM Start	0.00	Rating **	A	Issue No.	8
LM End	0.00	Issue Type +	Ma	Location *	
Category	Pump Stations			GPS Latitude/Longitude	
				Start	End
Item	Power			38.931815 °	38.931815 °
				-121.634331 °	-121.634331 °
DWR ID	DWR_NA0060_21_t_2012_8				
Action/Comments					
Inspector Comments: The structure is on the grid with emergency backup generator.

View of the emergency backup generator.

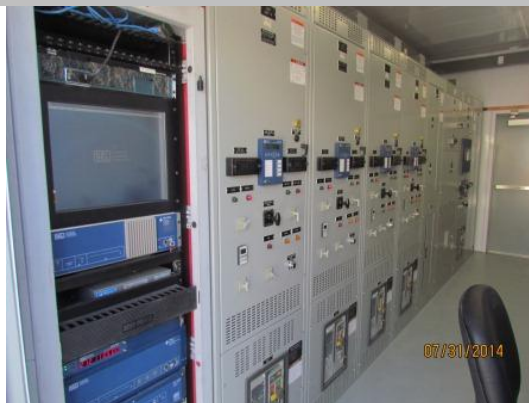
Photo 1 of 1 : ST_2014_NA0060_21_11_20140731_00015.jpg

LM Start	0.00	Rating **	A	Issue No.	11
LM End	0.00	Issue Type +	Ma	Location *	
Category	Pump Stations			GPS Latitude/Longitude	
				Start	End
Item	Pump Control Systems			38.931815 °	38.931815 °
				-121.634331 °	-121.634331 °
DWR ID	DWR_NA0060_21_t_2012_11				
Action/Comments					
Inspector Comments: Pump control systems on site are new and appear to be in working order.

View of the control room.

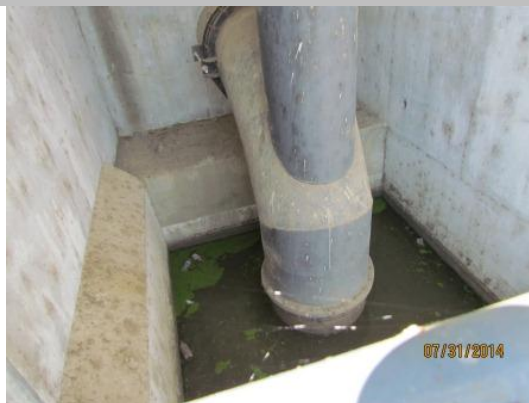
Photo 1 of 1 : ST_2014_NA0060_21_12_20140731_00016.jpg

LM Start	0.00	Rating **	A	Issue No.	12
LM End	0.00	Issue Type +	Ma	Location *	
Category	Pump Stations			GPS Latitude/Longitude	
				Start	End
Item	Sumps/Wet Well			38.931815 °	38.931815 °
				-121.634331 °	-121.634331 °
DWR ID	DWR_NA0060_21_t_2012_12				
Action/Comments					
Inspector Comments: Sumps are clear and free of debris.

View of the wet well.

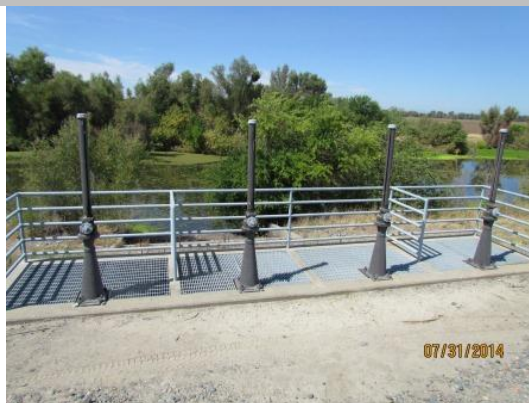
Photo 1 of 1 : ST_2014_NA0060_21_17_20140731_00018.jpg

LM Start	0.00	Rating **	A	Issue No.	17
LM End	0.00	Issue Type +	Ma	Location *	
Category	Pump Stations			GPS Latitude/Longitude	
				Start	End
Item	Manual Gate Operators			38.931815 °	38.931815 °
				-121.634331 °	-121.634331 °
DWR ID	DWR_NA0060_21_t_2012_17				
Action/Comments					
Inspector Comments: Manual gate operators appear to be in good working condition.

Photo shows sluice gate operators. Note: Operators can be operated either mechanically or manually.

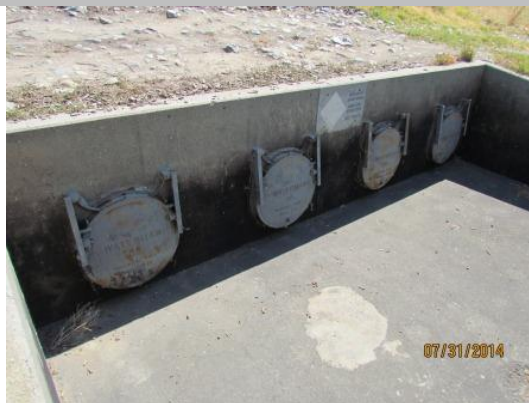
Photo 1 of 1 : ST_2014_NA0060_21_19_20140731_00019.jpg

LM Start	0.00	Rating **	A	Issue No.	19
LM End	0.00	Issue Type +	Ma	Location *	
Category	Pump Stations			GPS Latitude/Longitude	
				Start	End
Item	Flap Gates			38.931815 °	38.931815 °
				-121.634331 °	-121.634331 °
DWR ID	DWR_NA0060_21_t_2012_19				
Action/Comments					
Inspector Comments: Flap gates are in proper working condition, they show no signs of corrosion or damage.

Photo shows flap gates and concrete outfall structure.

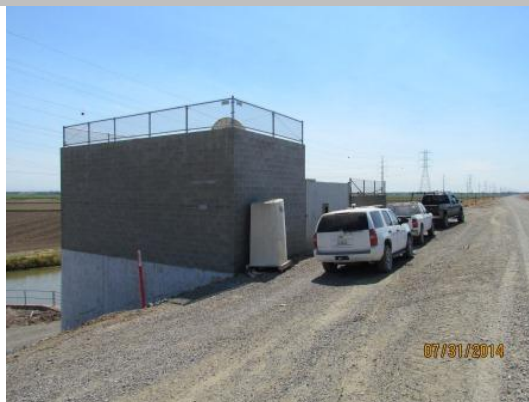
Photo 1 of 1 : ST_2014_NA0060_21_21_20140731_00020.jpg

LM Start	0.00	Rating **	A	Issue No.	21
LM End	0.00	Issue Type +	Ma	Location *	
Category	Pump Stations			GPS Latitude/Longitude	
				Start	End
Item	Security Fencing			38.931815 °	38.931815 °
				-121.634331 °	-121.634331 °
DWR ID	DWR_NA0060_21_t_2012_21				
Action/Comments					
Inspector Comments: Site is currently secured by a masonry brick wall.

Photo shows masonry brick wall which encloses the pump plant.

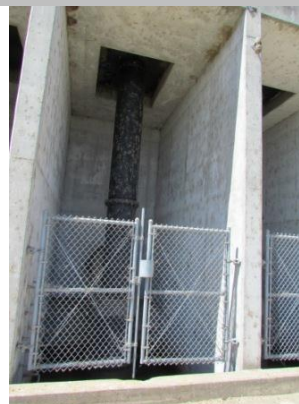
Photo 1 of 2 : ST_2014_NA0060_21_22_20140630_00009.jpg

LM Start	0.00	Rating **	A	Issue No.	22
LM End	0.00	Issue Type +	Ma	Location *	
Category	Pump Stations			GPS Latitude/Longitude	
				Start	End
Item	Intake and Discharge Pipes			38.931815 °	38.931815 °
				-121.634331 °	-121.634331 °
DWR ID	DWR_NA0060_21_t_2012_22				
Action/Comments					
Inspector Comments: No visible deficiencies observed in the pipe's condition.

Photo shows pump intake pipe, typical.

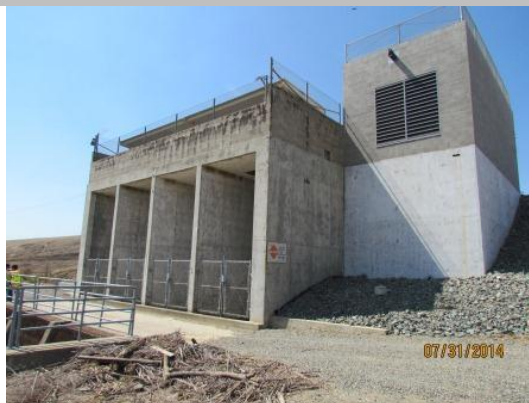
Photo 2 of 2 : ST_2014_NA0060_21_22_20140731_00021.jpg

LM Start	0.00	Rating **	A	Issue No.	22 (cont)	
LM End	0.00	Issue Type +	Ma	Location *		
Category	Pump Stations			GPS Latitude/Longitude		
				Start		End
Item	Intake and Discharge Pipes			38.931815 °		38.931815 °
				-121.634331 °		-121.634331 °
DWR ID	DWR_NA0060_21_t_2012_22					
Action/Comments						
Inspector Comments: No visible deficiencies observed in the pipe's condition.

View of the intake wells.

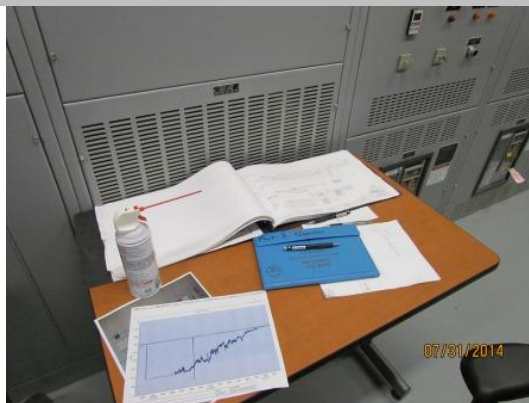
Photo 1 of 1 : ST_2014_NA0060_22_1_20140731_00011.jpg

LM Start	0.00	Rating **	A	Issue No.	1	
LM End	0.00	Issue Type +	Ma	Location *		
Category	Pump Stations			GPS Latitude/Longitude		
				Start	End	
Item	Operating Log			39.026449 °	39.026449 °	
				-121.726937 °	-121.726937 °	
DWR ID	DWR_NA0060_22_t_2012_1					
Action/Comments						
Inspector Comments: Operation log is located at the site.

View of the operating log.

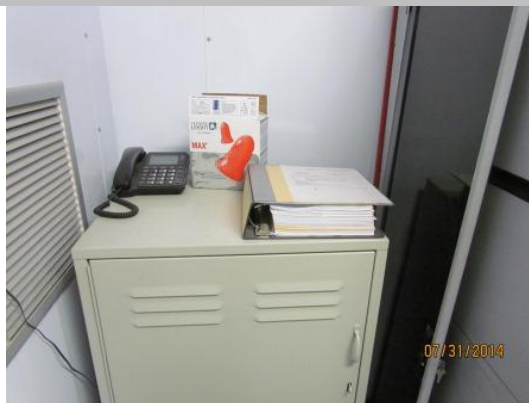
Photo 1 of 1 : ST_2014_NA0060_22_4_20140731_00013.jpg

LM Start	0.00	Rating **	A	Issue No.	4
LM End	0.00	Issue Type +	Ma	Location *	
Category	Pump Stations			GPS Latitude/Longitude	
				Start	End
Item	Communications			39.026449 °	39.026449 °
				-121.726937 °	-121.726937 °
DWR ID	DWR_NA0060_22_t_2012_4				
Action/Comments					
Inspector Comments: Operator has two-way radio and cellular phone available to them. The remote control system is currently being tested and should be ready by the start of flood season.

View of the on-site telephone.

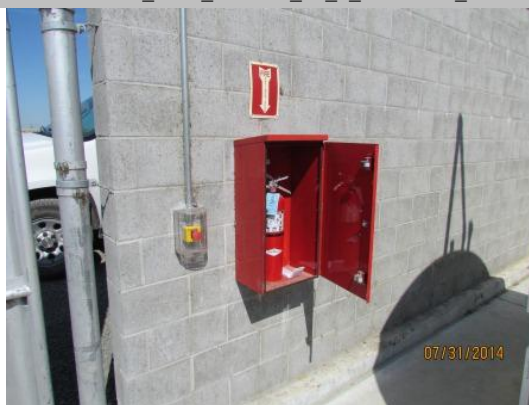
Photo 1 of 1 : ST_2014_NA0060_22_5_20140731_00014.jpg

LM Start	0.00	Rating **	A	Issue No.	5
LM End	0.00	Issue Type +	Ma	Location *	
Category	Pump Stations			GPS Latitude/Longitude	
				Start	End
Item	Safety			39.026449 °	39.026449 °
				-121.726937 °	-121.726937 °
DWR ID	DWR_NA0060_22_t_2012_5				
Action/Comments					
Inspector Comments: Site is under construction safety wear is required during construction (hard hat, vest and eyewear). Some of the hazards may include moving equipment.

View of the emergency shutoff switch and fire extinguisher.

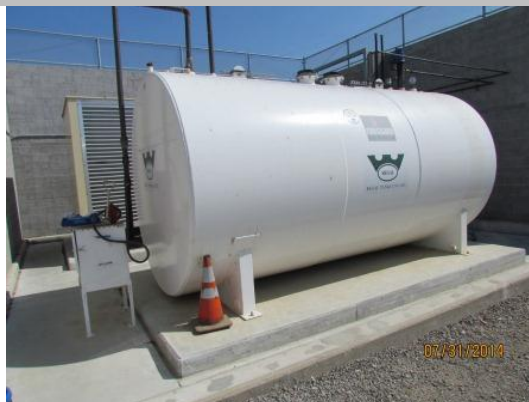
Photo 1 of 1 : ST_2014_NA0060_22_8_20140731_00015.jpg

LM Start	0.00	Rating **	A	Issue No.	8
LM End	0.00	Issue Type +	Ma	Location *	
Category	Pump Stations			GPS Latitude/Longitude	
				Start	End
Item	Power			39.026449 °	39.026449 °
				-121.726937 °	-121.726937 °
DWR ID	DWR_NA0060_22_t_2012_8				
Action/Comments					
Inspector Comments: The structure is on the grid with emergency backup generator.

View of the emergency backup generator and fuel.

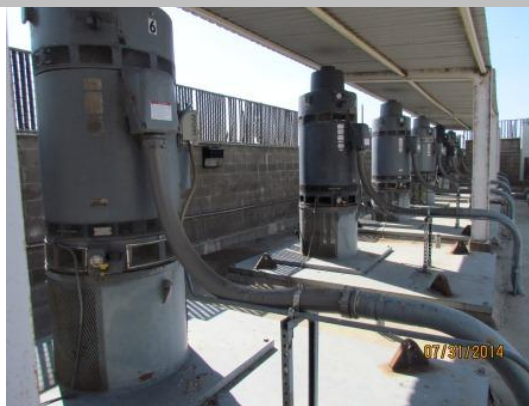
Photo 1 of 1 : ST_2014_NA0060_22_10_20140731_00016.jpg

LM Start	0.00	Rating **	A	Issue No.	10
LM End	0.00	Issue Type +	Ma	Location *	
Category	Pump Stations			GPS Latitude/Longitude	
				Start	End
Item	Motors, Engines, Fans & Gear Reducers			39.026449 °	39.026449 °
				-121.726937 °	-121.726937 °
DWR ID	DWR_NA0060_22_t_2012_10				
Action/Comments					
Inspector Comments: These items appear to be maintained and in operating condition.

View of the pump motors.

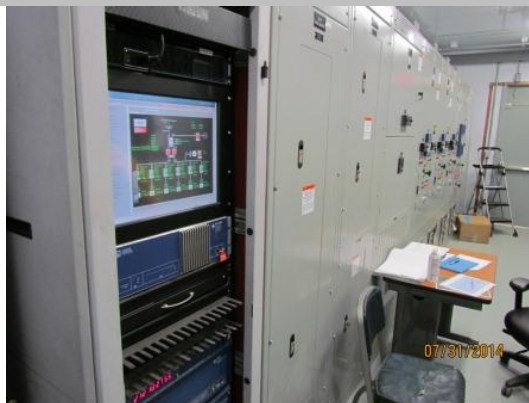
Photo 1 of 1 : ST_2014_NA0060_22_11_20140731_00017.jpg

LM Start	0.00	Rating **	A	Issue No.	11
LM End	0.00	Issue Type +	Ma	Location *	
Category	Pump Stations			GPS Latitude/Longitude	
				Start	End
Item	Pump Control Systems			39.026449 °	39.026449 °
				-121.726937 °	-121.726937 °
DWR ID	DWR_NA0060_22_t_2012_11				
Action/Comments					
Inspector Comments: Pump control systems on site are new and appear to be in working order.

View of the pump controls.

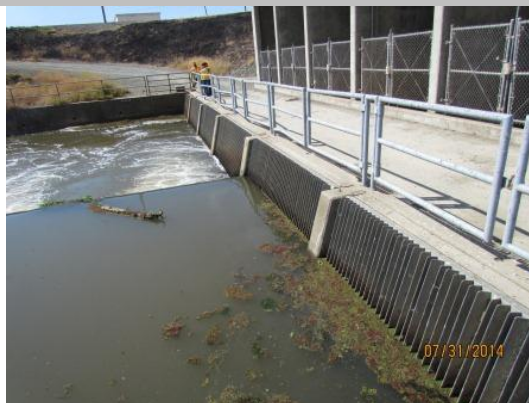
Photo 1 of 1 : ST_2014_NA0060_22_13_20140731_00019.jpg

LM Start	0.00	Rating **	A	Issue No.	13
LM End	0.00	Issue Type +	Ma	Location *	
Category	Pump Stations			GPS Latitude/Longitude	
				Start	End
Item	Trash Racks			39.026449 °	39.026449 °
				-121.726937 °	-121.726937 °
DWR ID	DWR_NA0060_22_t_2012_13				
Action/Comments					
Inspector Comments: Trash rack is secure and free of debris.

View of the trash racks.

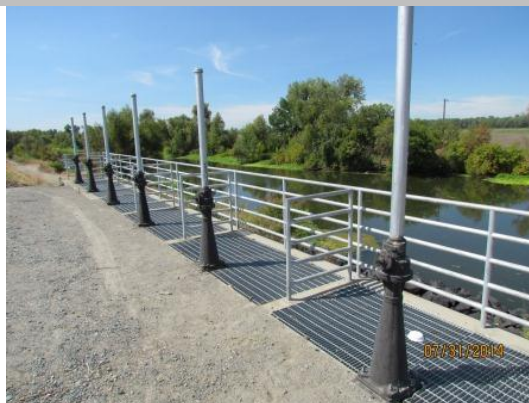
Photo 1 of 1 : ST_2014_NA0060_22_17_20140731_00020.jpg

LM Start	0.00	Rating **	A	Issue No.	17
LM End	0.00	Issue Type +	Ma	Location *	
Category	Pump Stations			GPS Latitude/Longitude	
				Start	End
Item	Manual Gate Operators			39.026449 °	39.026449 °
				-121.726937 °	-121.726937 °
DWR ID	DWR_NA0060_22_t_2012_17				
Action/Comments					
Inspector Comments: Manual gate operators appear to be in good working condition.

Photo shows controls for sluice gates.

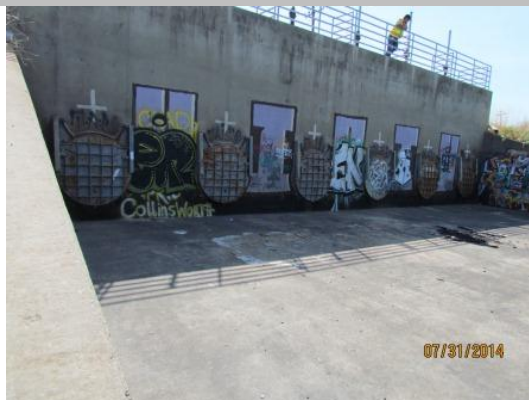
Photo 1 of 1 : ST_2014_NA0060_22_19_20140731_00022.jpg

LM Start	0.00	Rating **	A	Issue No.	19
LM End	0.00	Issue Type +	Ma	Location *	
Category	Pump Stations			GPS Latitude/Longitude	
				Start	End
Item	Flap Gates			39.026449 °	39.026449 °
				-121.726937 °	-121.726937 °
DWR ID	DWR_NA0060_22_t_2012_19				
Action/Comments					
Inspector Comments: Flap gates are in proper working condition, they show no signs of corrosion or damage.

View of the flap gates.

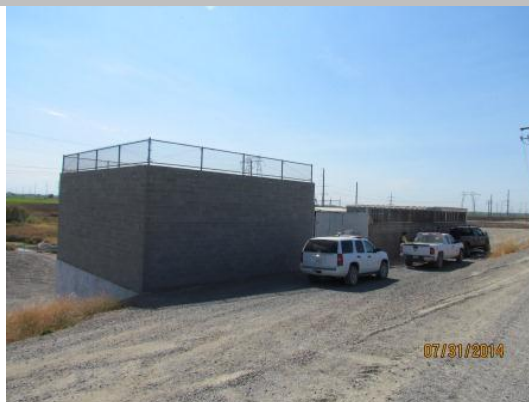
Photo 1 of 1 : ST_2014_NA0060_22_21_20140731_00023.jpg

LM Start	0.00	Rating **	A	Issue No.	21
LM End	0.00	Issue Type +	Ma	Location *	
Category	Pump Stations			GPS Latitude/Longitude	
				Start	End
Item	Security Fencing			39.026449 °	39.026449 °
				-121.726937 °	-121.726937 °
DWR ID	DWR_NA0060_22_t_2012_21				
Action/Comments					
Inspector Comments: Site is currently secured by a masonry brick wall.

Photo shows masonry block wall which encloses the site.

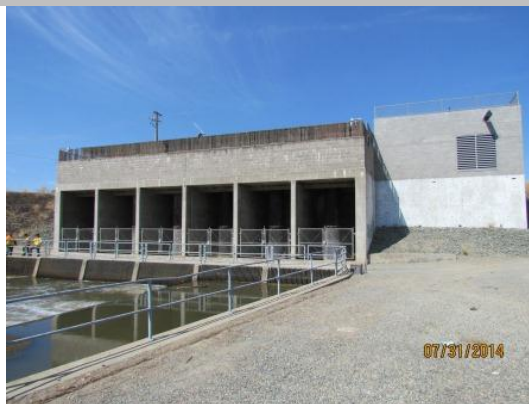
Photo 1 of 1 : ST_2014_NA0060_22_22_20140731_00024.jpg

LM Start	0.00	Rating **	A	Issue No.	22
LM End	0.00	Issue Type +	Ma	Location *	
Category	Pump Stations			GPS Latitude/Longitude	
				Start	End
Item	Intake and Discharge Pipes			39.026449 °	39.026449 °
				-121.726937 °	-121.726937 °
DWR ID	DWR_NA0060_22_t_2012_22				
Action/Comments					
Inspector Comments: No visible deficiencies observed in the pipe's condition.

View of the intake structure.

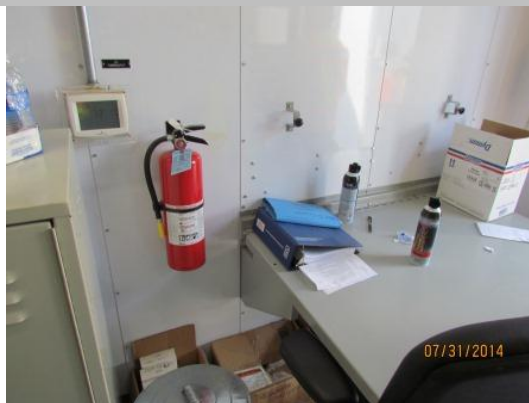
Photo 1 of 1 : ST_2014_NA0060_23_1_20140805_00010.jpg

LM Start	0.00	Rating **	A	Issue No.	1	
LM End	0.00	Issue Type +	Ma	Location *		
Category	Pump Stations			GPS Latitude/Longitude		
				Start	End	
Item	Operating Log			39.120096 °	39.120096 °	
				-121.779234 °	-121.779234 °	
DWR ID	DWR_NA0060_23_t_2012_1					
Action/Comments						
Inspector Comments: Operation log is at the site.

View of the Operating Log.

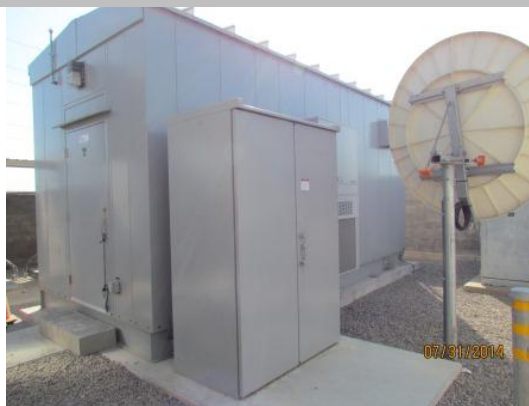
Photo 1 of 1 : ST_2014_NA0060_23_3_20140805_00011.jpg

LM Start	0.00	Rating **	A	Issue No.	3
LM End	0.00	Issue Type +	Ma	Location *	
Category	Pump Stations			GPS Latitude/Longitude	
				Start	End
Item	Plant Building			39.120096 °	39.120096 °
				-121.779230 °	-121.779230 °
DWR ID	DWR_NA0060_23_t_2012_3				
Action/Comments					
Inspector Comments: Plant building appears to be in good working condition. The project is currently under construction.

View of the Plant control building.

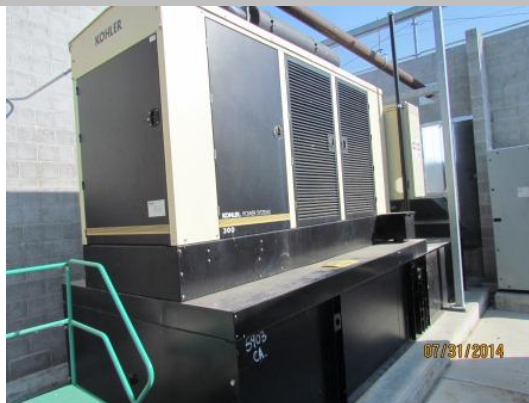
Photo 1 of 1 : ST_2014_NA0060_23_8_20140805_00012.jpg

LM Start	0.00	Rating **	A	Issue No.	8
LM End	0.00	Issue Type +	Ma	Location *	
Category	Pump Stations			GPS Latitude/Longitude	
				Start	End
Item	Power			39.120096 °	39.120096 °
				-121.779230 °	-121.779230 °
DWR ID	DWR_NA0060_23_t_2012_8				
Action/Comments					
Inspector Comments: The structure is on the grid with emergency generator backup.

View of the emergency backup generator.

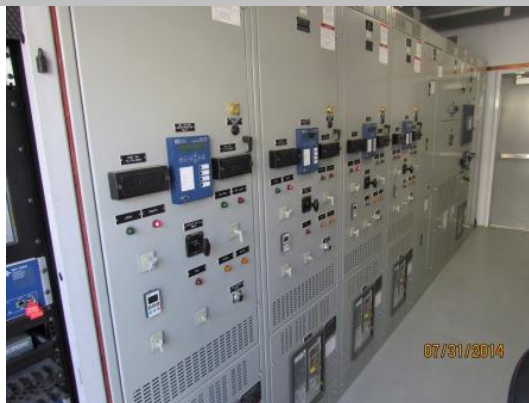
Photo 1 of 1 : ST_2014_NA0060_23_11_20140805_00014.jpg

LM Start	0.00	Rating **	A	Issue No.	11
LM End	0.00	Issue Type +	Ma	Location *	
Category	Pump Stations			GPS Latitude/Longitude	
				Start	End
Item	Pump Control Systems			39.120096 °	39.120096 °
				-121.779230 °	-121.779230 °
DWR ID	DWR_NA0060_23_t_2012_11				
Action/Comments					
Inspector Comments: Pump control systems on site are new and appear to be in working order.

View of the pump control panels.

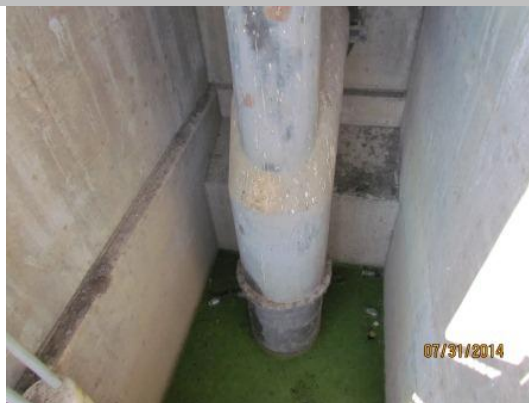
Photo 1 of 2 : ST_2014_NA0060_23_12_20140805_00015.jpg

LM Start	0.00	Rating **	A	Issue No.	12
LM End	0.00	Issue Type +	Ma	Location *	
Category	Pump Stations			GPS Latitude/Longitude	
				Start	End
Item	Sumps/Wet Well			39.120096 °	39.120096 °
				-121.779230 °	-121.779230 °
DWR ID	DWR_NA0060_23_t_2012_12				
Action/Comments					
Inspector Comments: Sumps are clear and free of debris.

View of the wet well.

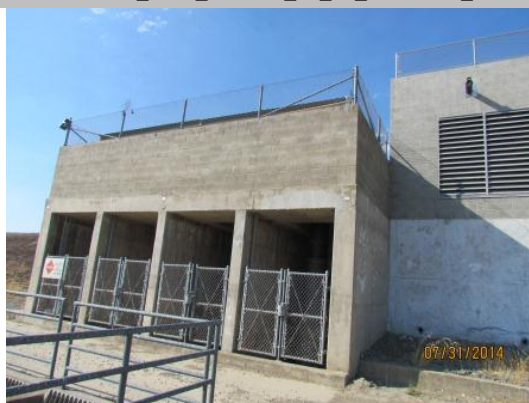
Photo 2 of 2 : ST_2014_NA0060_23_12_20140805_00016.jpg

View of the wet wells with controlled access.

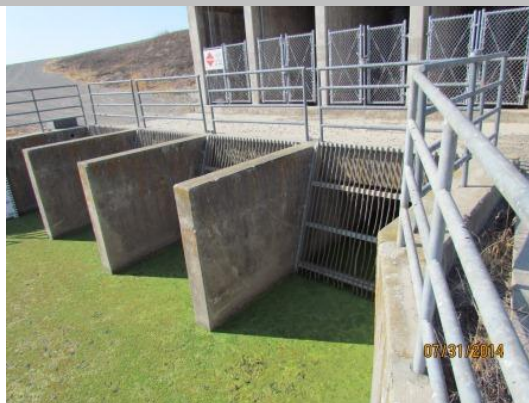
Photo 1 of 1 : ST_2014_NA0060_23_13_20140805_00017.jpg

LM Start	0.00	Rating **	A	Issue No.	13
LM End	0.00	Issue Type +	Ma	Location *	
Category	Pump Stations			GPS Latitude/Longitude	
				Start	End
Item	Trash Racks			39.120096 °	39.120096 °
				-121.779230 °	-121.779230 °
DWR ID	DWR_NA0060_23_t_2012_13				
Action/Comments					
Inspector Comments: No debris present on trash racks, they appear to

Photo shows trash rack free of debris and other material.
